# SUMMARY OF APPRAISAL: MIDLAND COTTAGES

## > Enhancement opportunities

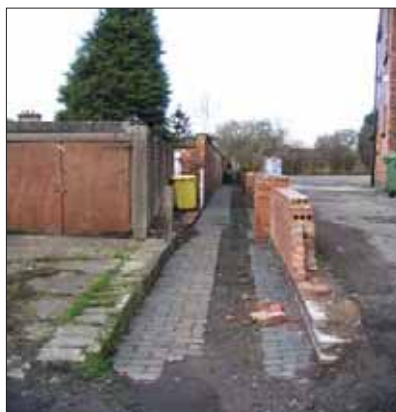
Wall to the pub car park and garages at end of terrace.

Repairs and replacement of boundary walls are required in places, whilst more appropriate treatments in other places would enhance the properties. Attempts should be made to persuade the railway company to paint the unattractive galvanised fence to reduce its impact and to provide some improved planting behind it. The grass verge between the fence and the cottages could also be planted with shrubs to reduce the impact of the fence and so significantly enhance the setting of the cottages.

The garages built at the ends of the terraces lack the quality of materials and detailing of the cottages. Their replacement in more appropriate materials and with pitched roofs would be a significant improvement to the character of the area.

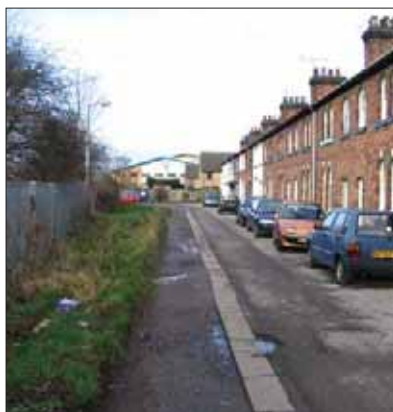
View north along the verge

The track in front of the cottages is rough and could be resurfaced in bonded gravel or another appropriate finish with the footway repaved with setts or blue brick pavers. The large kerbs on the west side of the lane could be reused on the cottage side were the road reconfigured.

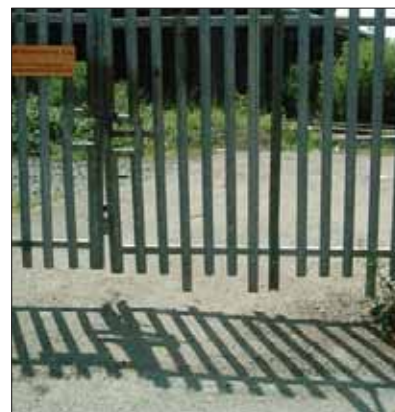
Galvanised railway fence
