SUMMARY OF APPRAISAL: MIDLAND COTTAGES

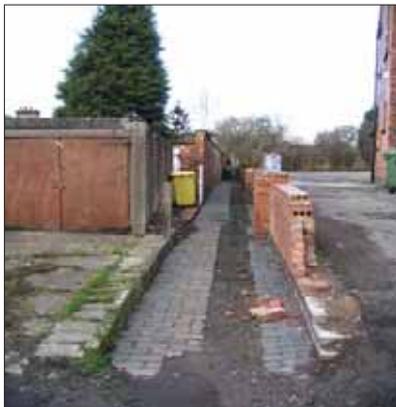
Wall to the pub car park and garages at end of terrace.

Repairs and replacement of boundary walls are required in places, whilst more appropriate treatments in other places would enhance the properties. Attempts should be made to persuade the railway company to paint the unattractive galvanised fence to reduce its impact and to provide some improved planting behind it. The grass verge between the fence and the cottages could also be planted with shrubs to reduce the impact of the fence and so significantly enhance the setting of the cottages.

The garages built at the ends of the terraces lack the quality of materials and detailing of the cottages. Their replacement in more appropriate materials and with pitched roofs would be a significant improvement to the character of the area.

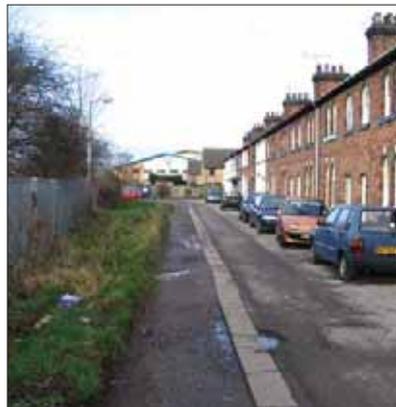
View north along the verge

The track in front of the cottages is rough and could be resurfaced in bonded gravel or another appropriate finish with the footway repaved with setts or blue brick pavers. The large kerbs on the west side of the lane could be reused on the cottage side were the road reconfigured.

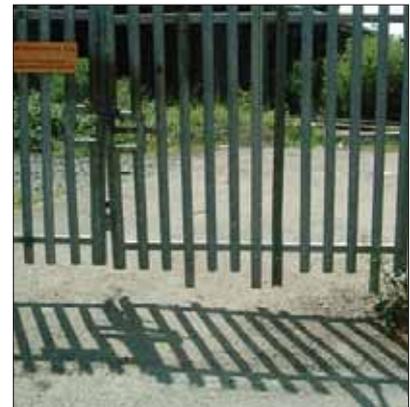
Galvanised railway fence
